Manhole Inspection Summary

Manhole # S65G__018MH

Insp Date: **6/3/08 10:47 AM**

Location Address: **6200 Eastern Ave.**

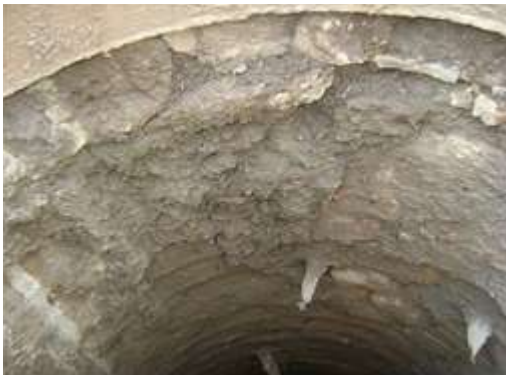
Defect 1

Condition: ☐ Sound ☐ Cracked ☐ Root Intrusion ☒ **Loose Brick** ☒ **Deteriorated**

Infiltration: ☐ None ☒ **Joint** ☐ Cracks ☒ **Mortar** ☐ Roots ☐ Wall

infiltration evidence in chimney

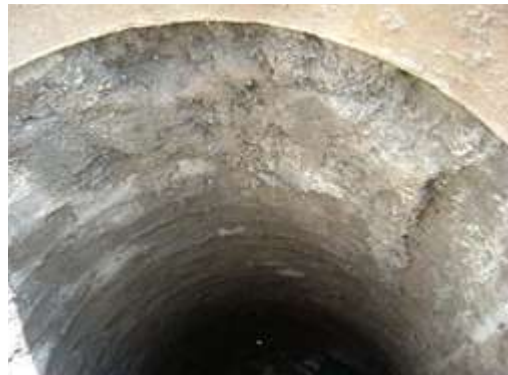
Defect 2

infiltration evidence in chimney

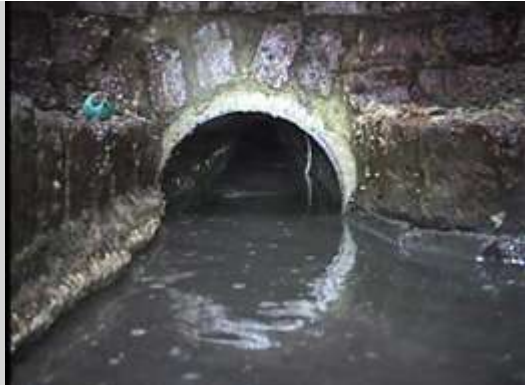
12 O'Clock Outflow

10 in. Circular Gravity Sewer
Pipe Out @ 12 O'Clock

Pipe Height: **9.6** (in.) Rod and Bar (Angled)
Pipe Material: **Clay** ☐ Pipe Lined
Invert Depth: **11.25** (ft.) Flow Characteristics: **Slow**
Deposits: ☐ None ☐ Mud ☐ Grassy ☒ Debris ☒ Grease
Silt Depth: **0.75** (in.) Deposits Extent: **Light**
Infiltration: **None** Pipe Seal Cond: **Sound**

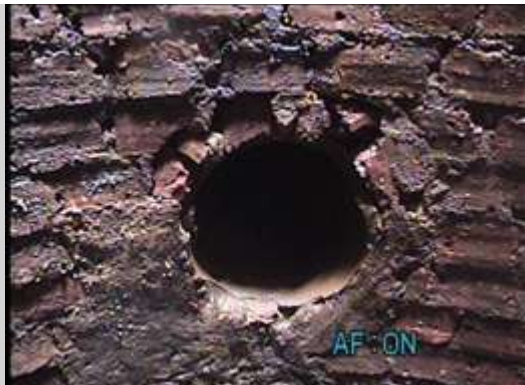
3 O'Clock Inflow

8 in. Circular Gravity Sewer
Pipe In @ 3 O'Clock

Pipe Height: **8.4** (in.) Rod and Bar (Angled)
Pipe Material: **Clay** ☐ Pipe Lined
Invert Depth: **8.33** (ft.) Flow Characteristics: **Slow**
Deposits: ☐ None ☐ Mud ☐ Grassy ☒ Debris ☐ Grease
Silt Depth: **0.5** (in.) Deposits Extent: **Light**
Infiltration: **None** Pipe Seal Cond: **Sound**

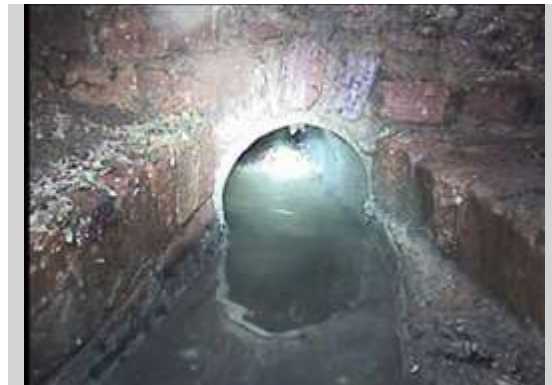
Drop In @ 3 O'Clock

Drop: **Outside** Rod and Bar
Angled: **Yes** Reading: **10.00** (ft.)
Inv Depth: **11.00** (ft.)
Drop Condition: **Open**

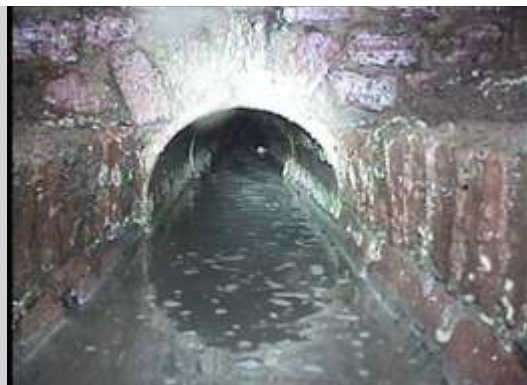
6 O'Clock Inflow

10 in. Circular Gravity Sewer
Pipe In @ 6 O'Clock

Deposits: ☐ None ☐ Mud ☒ **Sludge** ☐ Debris ☐ Grease

Silt Depth: **0.5** (in.) Deposits Extent: **Light**
